Manhole Inspection Summary

Manhole # S21GG2031MH

Insp Date: **11/17/06 10:43 AM**

Location Address: **5824 CLARKS HILL**

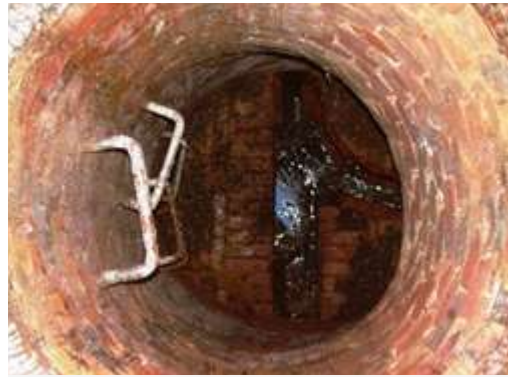
Top View

Corroded steps. Evidence of surcharge - Bench debris. Channel debris.

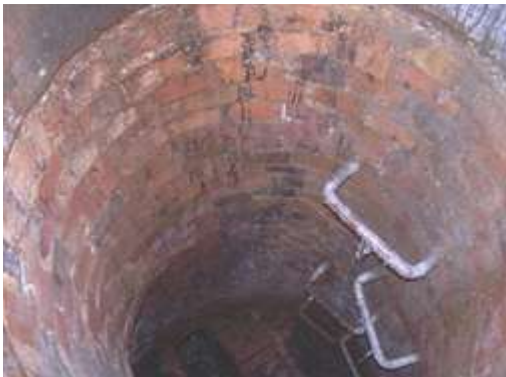
Defect

Adjustment deterioration and infiltration. Barrel infiltration.

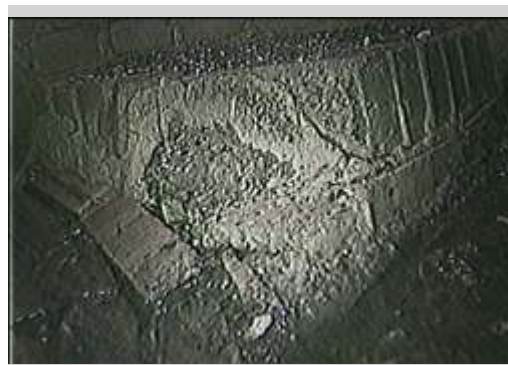
Defect

Bench and Channel deterioration and cracks.

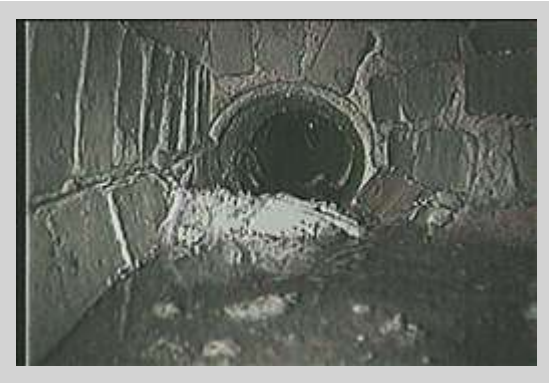
8 in. Circular Gravity Sewer Pipe Out @ 12 O'Clock

Channel deterioration.

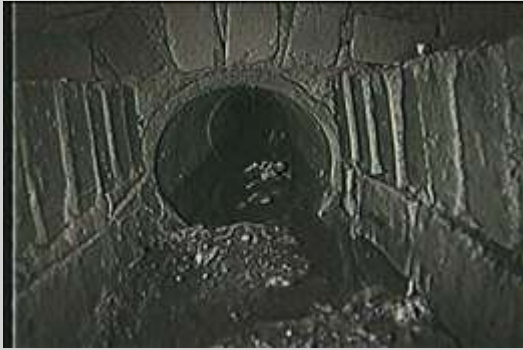
Pipe In @ 6 O'Clock

Barrel deterioration and infiltration. Channel deterioration.
